# Manhole Inspection Summary

Manhole # S27AA\_042MH

Insp Date: **11/27/07 10:59 AM**

**Location** Address: **815 FREMONT AVE**

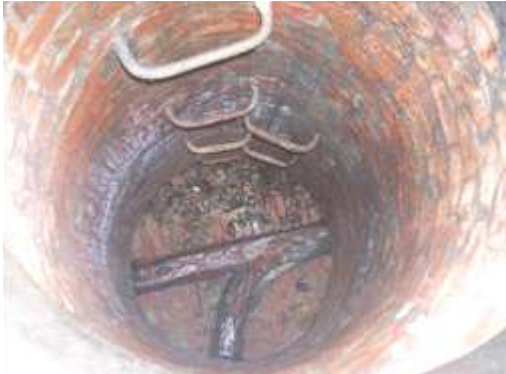
Defect 2

Count: **6** Missing: **1** ☒ **Corroded**

MISSING AND CORRODED STEPS

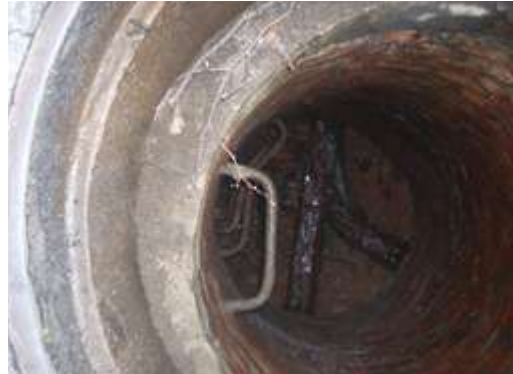
Defect 1

Offset: **4** (in.)

FRAME OFFSET

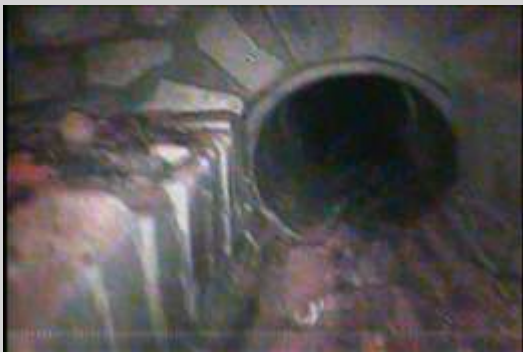
12 O'Clock Outflow

8 in. Circular Gravity Sewer  
Pipe Out @ 12 O'Clock

Pipe Height: **8.4** (in.) Rod and Bar (Angled)  
Pipe Material: **Clay** ☐ Pipe Lined  
Invert Depth: **11.51** (ft.) Flow Characteristics: **Slow**  
Deposits: ☒ None ☐ Mud ☐ Sludge ☐ Debris ☐ Grease  
Silt Depth: (in.) Deposits Extent:  
Infiltration: **None** Pipe Seal Cond: **Sound**

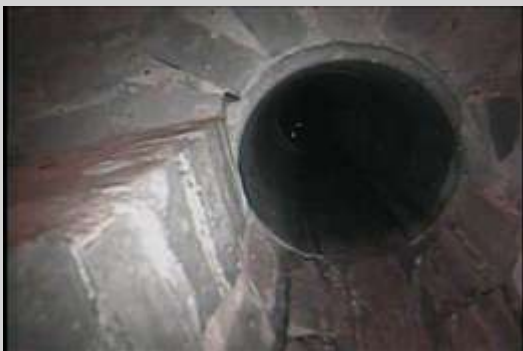
4 O'Clock Inflow

8 in. Circular Gravity Sewer  
Pipe In @ 4 O'Clock

Pipe Height: **8.4** (in.) Rod and Bar (Angled)  
Pipe Material: **Clay** ☐ Pipe Lined  
Invert Depth: **11.15** (ft.) Flow Characteristics: **Slow**  
Deposits: ☒ None ☐ Mud ☐ Sludge ☐ Debris ☐ Grease  
Silt Depth: (in.) Deposits Extent:  
Infiltration: **None** Pipe Seal Cond: **Sound**

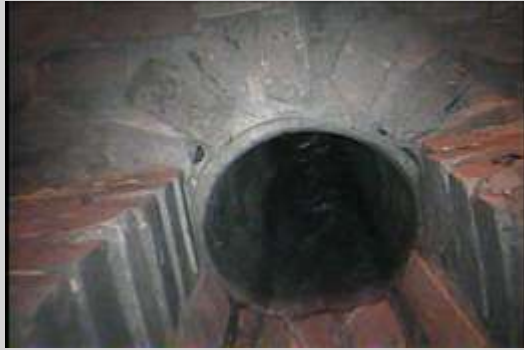
6 O'Clock Inflow

Infiltration: **None** Pipe Seal Cond: **Sound**
